By the Lanchester Gun Company into the possibility of
shell damage to the vessel Western

THE LANCHESTER GUN COMPANY

REPORT OF LANCHESTER GUN COMPANY: TECHNICAL EVALUATION OF HOLES IN FORECASTLE DECK OF FISHING VESSEL 'WESTERN', FOUNDERED ON FEBRUARY 6TH 1981

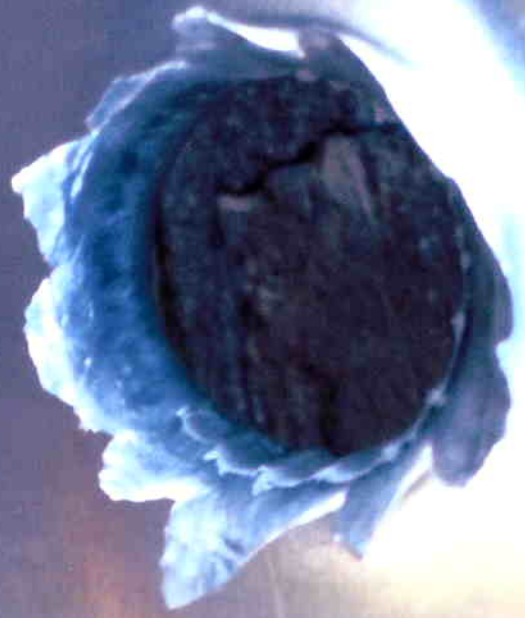
I obtained a sheet of 6mm aluminium (aluminium alloys have improved considerably since 1986, and a slightly thinner sheet was judged to be more accurately comparable). I started by firing high-velocity and low-velocity 7.62 x 51mm rifle cartridges (the standard NATO calibre) through the sheet. Two shots were fired into the sheet at right-angles at 300 metres per second and two further shots at 800 metres per second. Photograph 1 shows the entry hole, and photograph 2 shows the exit hole, of the shot fired at 800 metres per second. Photograph 3 shows the entry, and Photograph 4 the exit, of the shot fired at 300 metres per second. The second firing at each velocity level gave results identical to the first, so these are not shown.

7.62 x 51 FMT

300 w/s

Ex IT

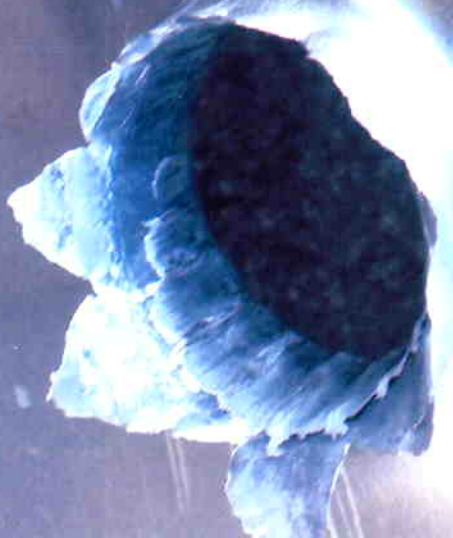
Next, it was necessary to investigate the effect of firing a full velocity cannon shell at the plate, and I selected a 30mm Rarden anti-tank shell, travelling at 1,070 metres per second. Photograph 5 shows the two entry holes, Photograph 6 the two exit holes, and Photograph 7 the two exit holes shown at right-angles. These photographs all show surprisingly similar results, in that a small ring of metal, almost like a crown, is forced out sideways from the entry hole, and the exit hole is surrounded by a cone of metal with ragged edges, again looking like a slightly taller crown. In all the above cases it is noticeable that the velocity of entry makes little difference; that is to say,

30 mm Rarden
Exit

1070 m/s

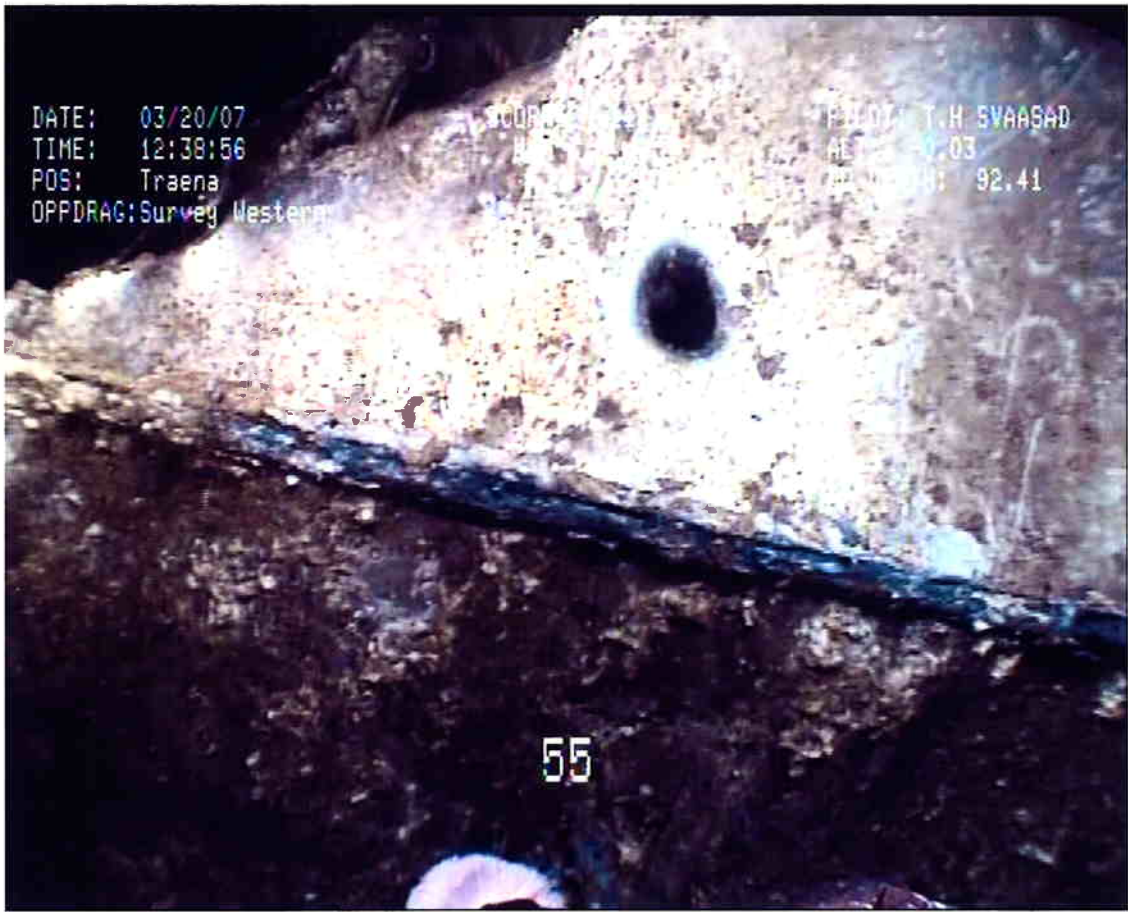
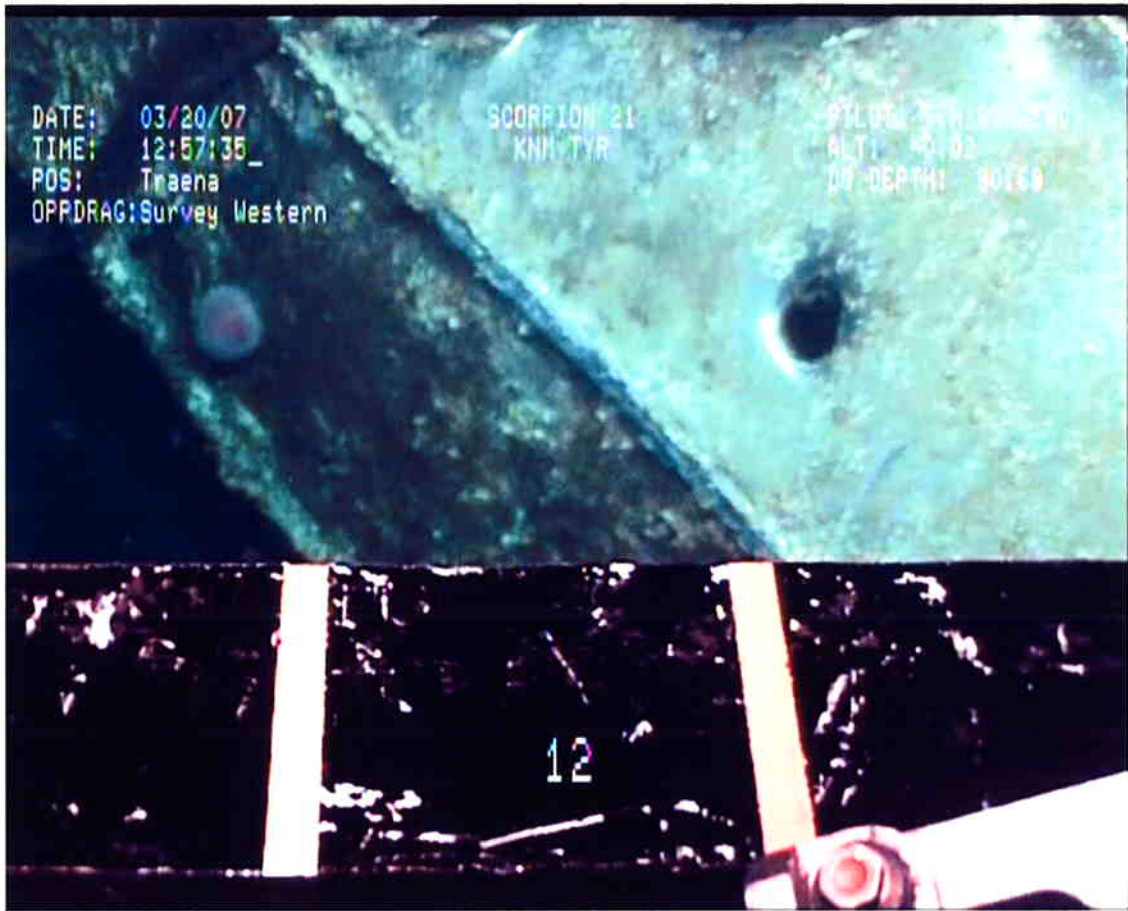
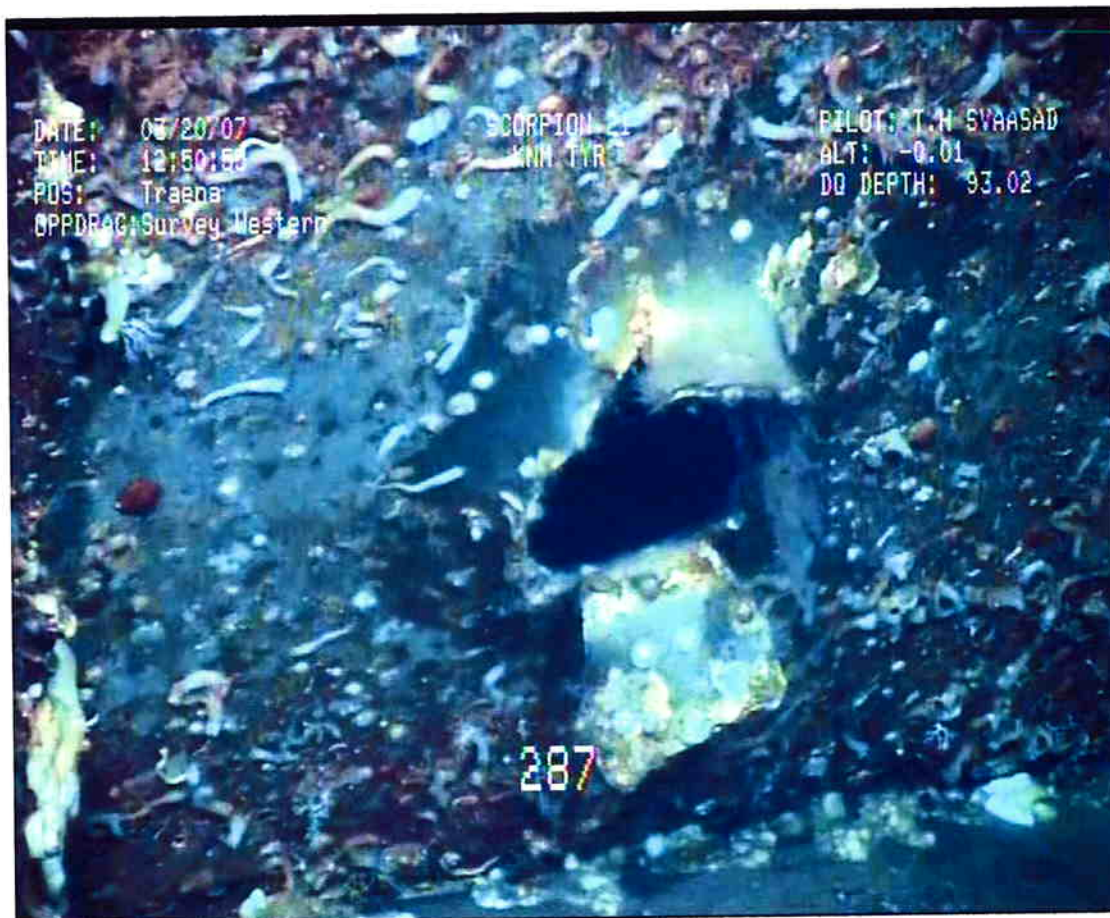
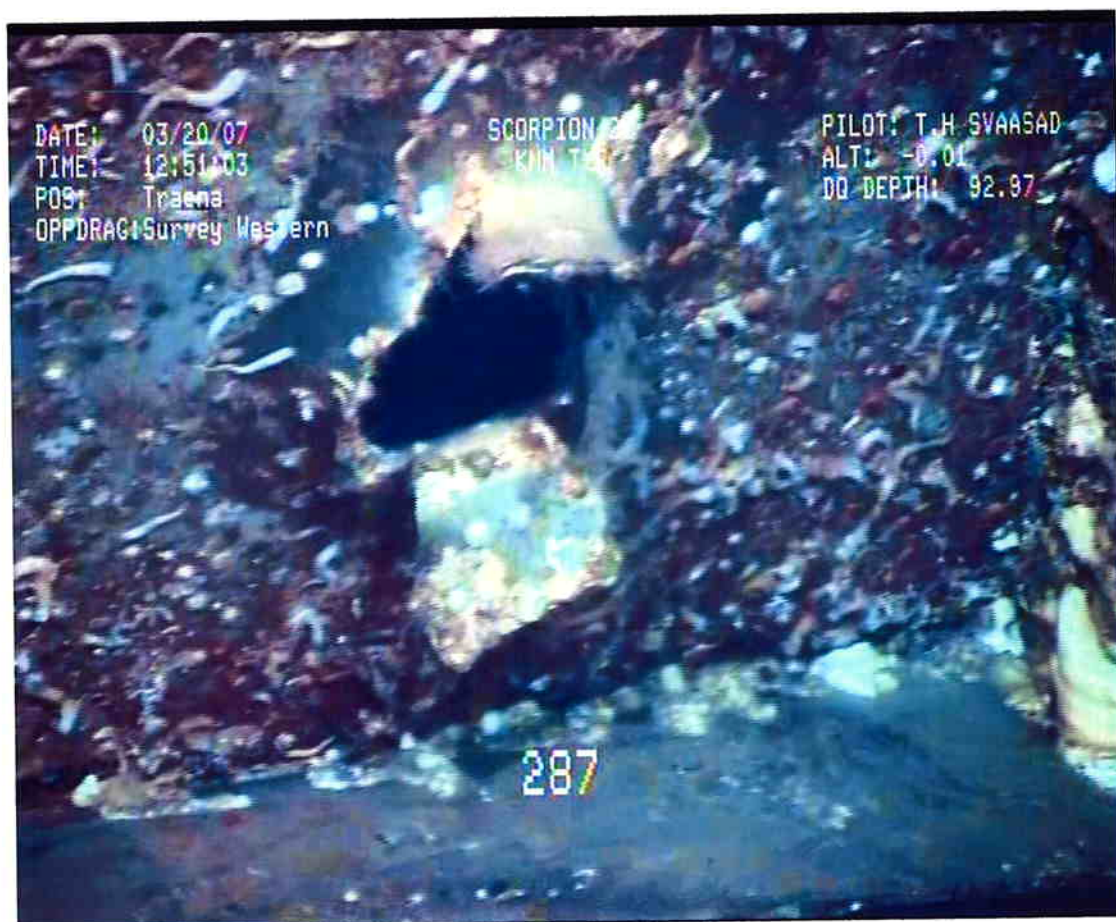
the 300 metres per second rifle round produces virtually identical results, both on entry and exit, to the 800 metres per second round, and to the Rarden projectile. It was therefore necessary to see if a blunter and slower projectile would produce results more akin to the hole shown in Photograph 8. This hole is the one from the starboard side, and is of approximately 80mm in diameter. However, in attempting to duplicate this hole, it was necessary to take notice of the fact that the angle of entry appears to be approximately 35° to the plane of the aluminium sheet itself. This can be determined by the degree of ovality of the hole, and also by the degree to which the torn flaps of metal on the inside of the hole are bent away from right-angles (as shown on Photograph 9).

However, in my opinion, the characteristics of the entry and exit holes are much more similar to the cannon round and the rifle round than they are to the hole in the ship for several reasons:- although the starboard side hole has an approximately similar entry characteristic to the 27mm rifle round, when viewed from the inside as in Photograph 9, it will be evident that there is no sign of the perfectly round entry that would be produced by a shell travelling at even low velocity. The hole is ragged, the edges are jagged, and in my opinion could not have been produced by a circular projectile, and the tearing of the metal and bending of it back would not occur at any velocity over about 50 metres per second. That is to say, instead of being folded back, the metal would be removed.

30 mm Radar

EXIT

1070 m/s

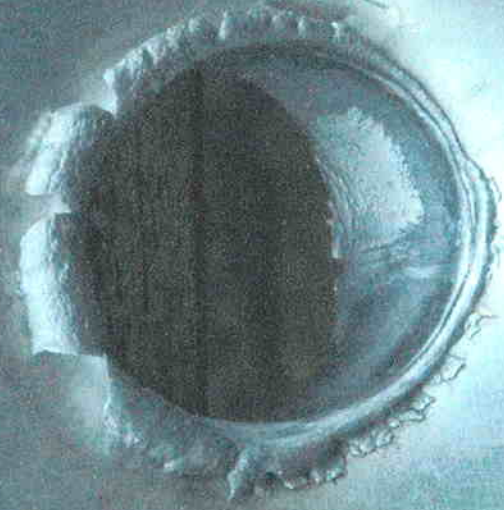
I therefore selected for this purpose a 2-bore (approximately 27mm) sporting rifle of my own manufacture, which I deliberately underloaded in order to give very low muzzle velocity (approximately 250 metres per second) and which had blunt-nosed projectiles. I then fired this at the sheet, both at right-angles and at a 35° angle, in order to attempt to replicate the starboard side hole. The first shot, fired at right-angles, is shown on the entry side on Photograph 10, and it will be seen that the results are similar to both the rifle shot and to the 30mm anti-tank round in Photographs 1 and 5. Photograph 11 shows the exit, which is again similar. Photograph 12 shows this exit hole at right-angles.

27mm 250m/s

ENTRY

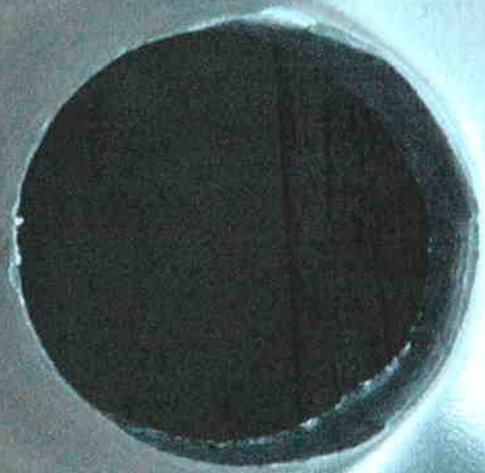
27 mm 250 m/s

EXIT

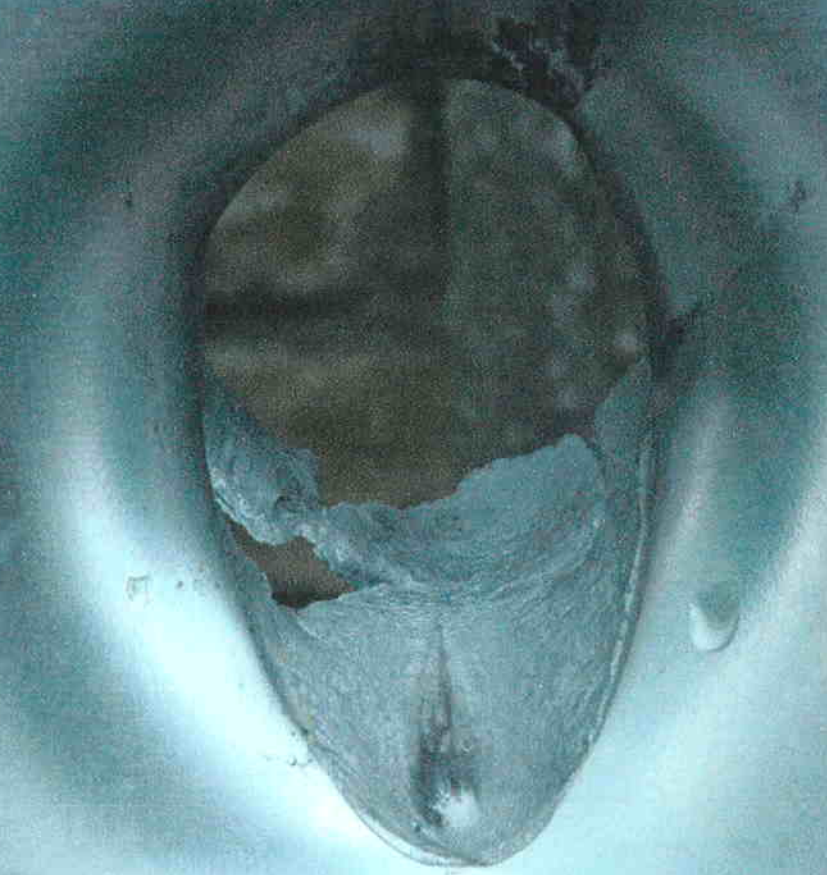
It was therefore determined that it would be necessary to fire a low velocity round (250 metres per second) at a similar entry angle to see if I could get closer to duplicating the hole on the starboard side. In this I was only partially successful. Photograph 13 shows the entry, showing a similar degree of ovality to the hole in the starboard side and Photograph 14 shows the exit hole (Photograph 15 shows the exit hole at right-angles). From this it will be seen that there are a few similarities with the entry hole on the starboard side:-

time to start to bend out of the way. That is to say, the projectile will have exited the metal before the surrounding metal can have time to start to be bent backwards. It will be noted that the 35° entry hole shown in Photograph 13 has a very large degree of annular depression, which is not duplicated in the other calibres, and it is evident that this degree of depression increases as the velocity of entry becomes lower.

27mm 250m/s

35 degrees entry angle

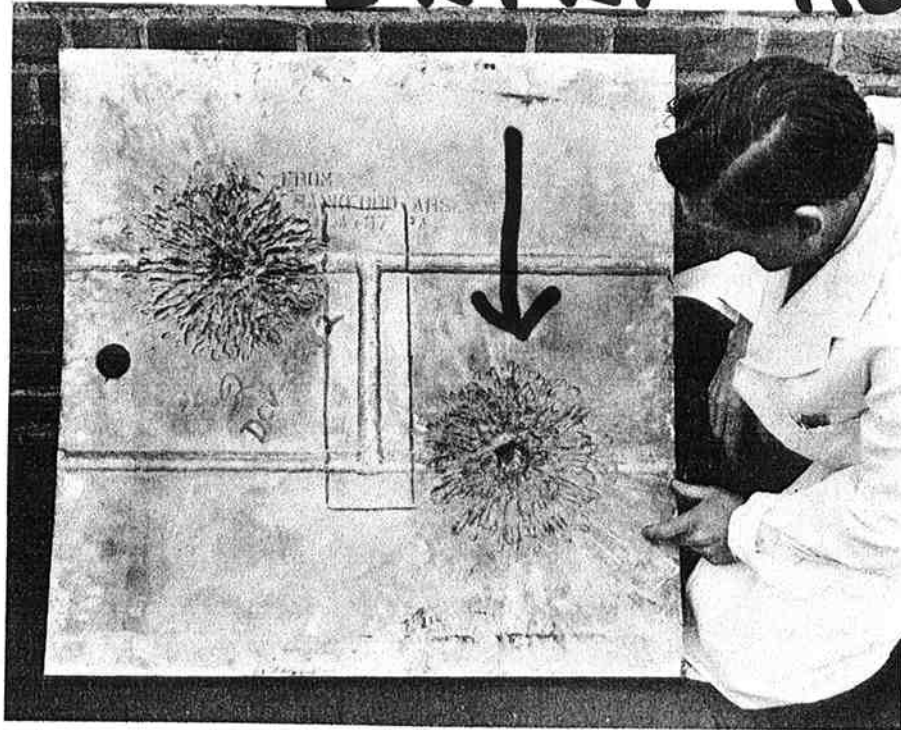
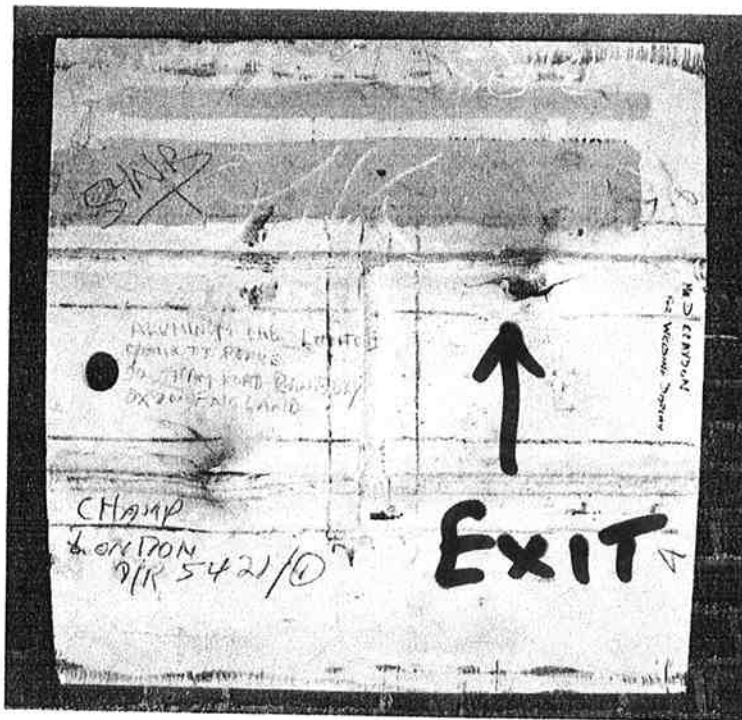
1. There is a degree of depression around the hole which is not clean punched: there is a gentle curve in the metal down to the edges of the hole.
2. The exit hole shows more tearing and a less perfect crown formation of the edges of the metal, and Photograph 15 demonstrates this again at right-angles.

27 mm 250 m/s
Exit (35 degrees)

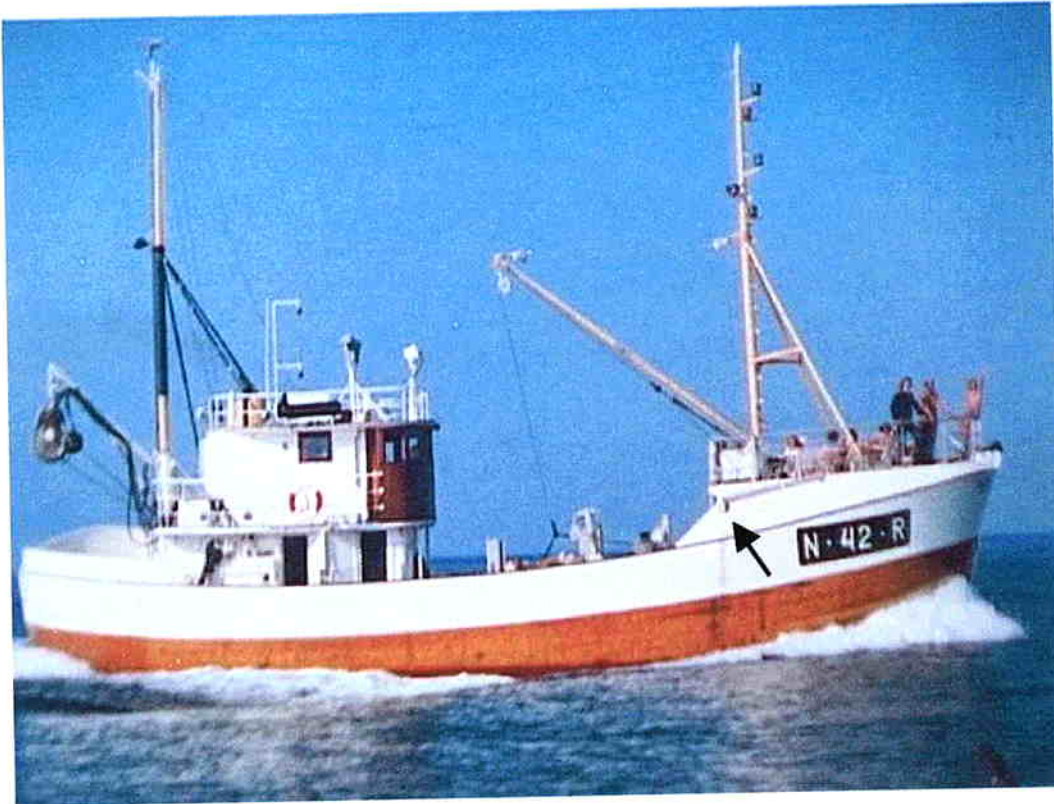
Photographs 17 and 18 are of the small hole in the port side and the large hole in the starboard side respectively. It must be pointed out that it would be very difficult, even if these two holes had been cannon shell holes, for comparatively small holes 2 metres above the water line to have had any effect on the vessel, to the extent of causing it to sink.

On the video I was given, there was only a very short duration of the 2006 submersible operation which shows the smaller hole in the port side, and I think I am right in saying that there is no interior shot of this hole: this is regrettable, since much more is learnt about the nature of the object penetrating from the inside of the hole than from the outside.

(Small) Hole in port side (aft of forecabin bulkhead) approximate position indicated by black arrow
